Figure 3-8. Simplified geologic cross-section of Yucca Mountain, west to east.

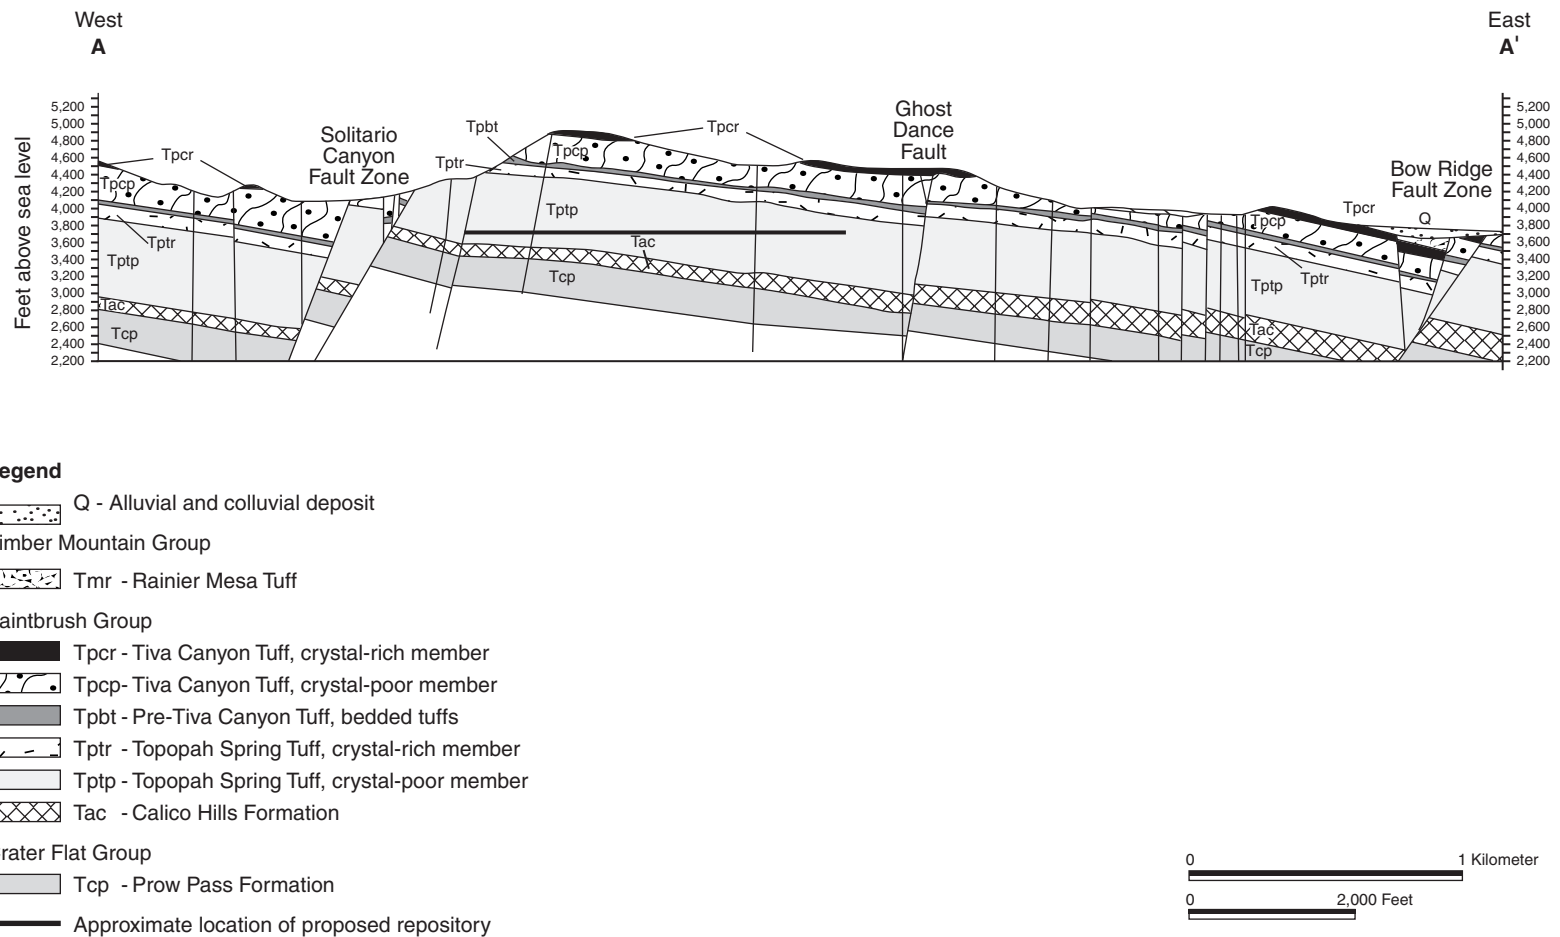
Note: Line of cross-section indicated on Figure 3-7. Faults consistent with Figure 3-10.
